# LOCATING LANDFILL LEAKS COVERED WITH WASTE

P. COLUCCI\*, G.T. DARILEK\*\*, D. L. LAINE\*\* AND A. BINLEY\*\*\*

**SUMMARY:** A newly constructed single-lined geomembrane municipal solid waste (MSW) landfill cell developed leaks after two to five meters of waste were placed in the cell. The primary liner was initially leak tested using an electrical leak location method after the protective drainage soil was placed on the liner. All leaks that were located were repaired. Therefore, the reported leakage was caused by damage to the liner during the placement of the waste material. Because the landfill had up to five meters of waste material covering the liner, a standard electrical leak location survey was not practical. Therefore the newly-developed Electrical Leak Imaging Method (ELIM) was used to locate leaks. Three leaks were located using ELIM. The leaks were repaired and no further leakage has been reported.

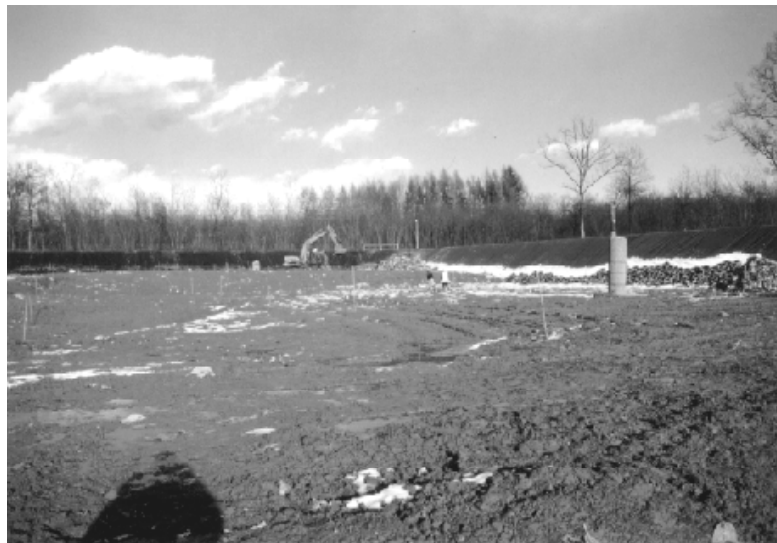
The landfill cell is lined with a single 2.5 mm HDPE liner and has a floor area of approximately one hectare. A thick geotextile was placed on the liner prior to covering the floor with one meter of coarse drainage gravel. The waste was covered with 30 cm of graded soil.

Figure 1. Photograph of Landfill Showing Survey Area

Leak monitoring for the landfill cell was provided by groundwater monitoring wells placed down gradient from the landfill. Figure 1 shows a view of the landfill cell.
