Landfill construction quality

Lessons learned from

electrical resistivity testing of geomembrane liners.

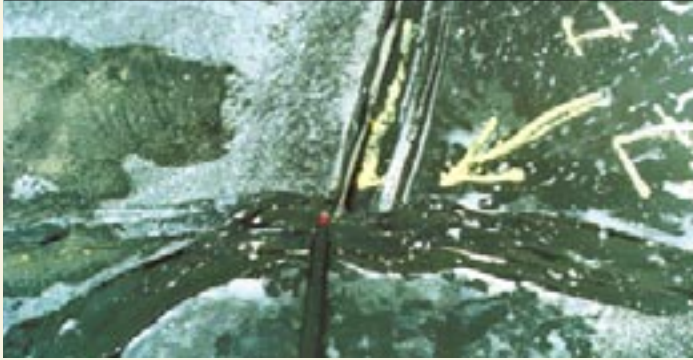
Photo 1: Many leaks occur on extrusion welds at "T" and "Y" joints and around pipe penetrations.

- 61% of the geomembrane leaks are on extrusion welds at "T" and "Y" joints and/or around pipe penetrations (**Photo 1**).
- 18% of the damage was caused by overheating and melt-throughs.
- 17% of the defects resulted from stones in the subgrade which punctured the geomembrane.
- 4% of the defects were caused by cuts in the geomembrane which were not noted or repaired during installation.

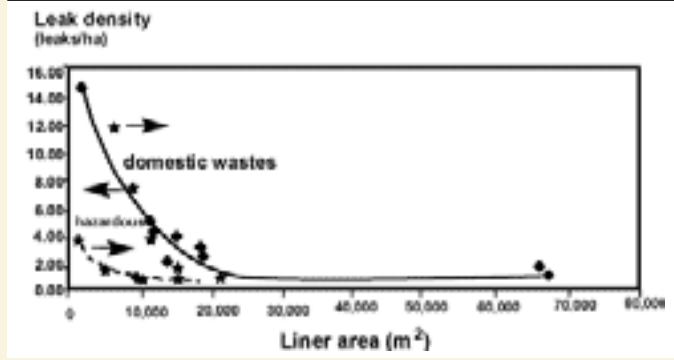
Figure 2: Leak distribution decreases as facility area increases.

This information, for covered and uncovered liners, can be compared with leaks found by Peggs and McEuen (2001) in a 640,000 m² (6,889,000 ft.²) uncovered liner as shown in Table 3. This leak distribution of 2 leaks/ha is in agreement with data generated by Rollin (1999), also for covered and uncovered liners. Rollin shows (Figure 2) leak distribution to decrease from about 15/ha to 2/ha as facility area increases beyond about 20,000 m² (215,300 ft.²).

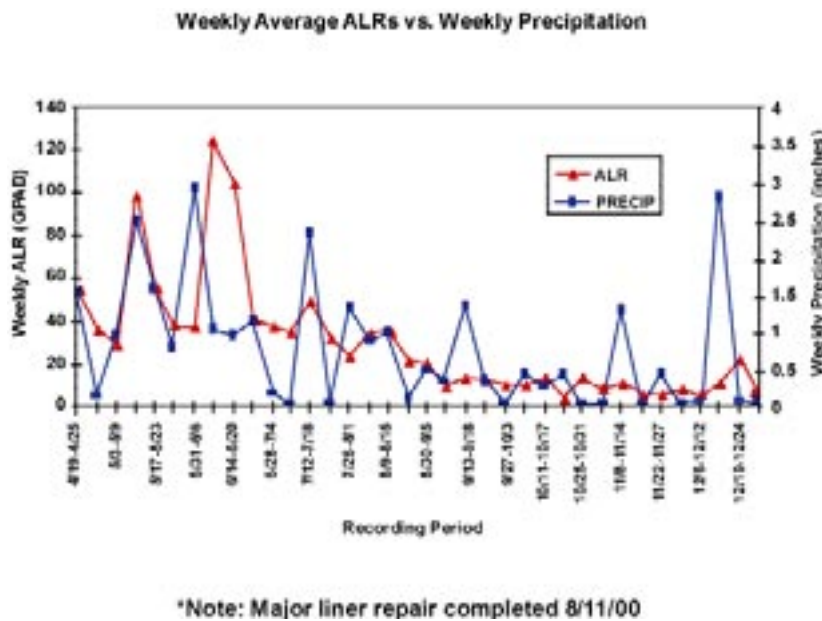
Figure 3: The consequences of an integrity survey on a new liner.

The consequences of performing an integrity survey on a newly constructed liner in a landfill cell are shown in Figure 3. This was one instance where a leak location survey was required when secondary

leachate flow rates were on the order of 60 or 70 gpad (600 and 700 lphd). Upon some repairs being made after the integrity survey, the flow rate was reduced to 7 to 14 gpad (70 to 140 lphd) for precipitation events that had caused much larger rates prior to the repairs being made. Often it is difficult to reduce flow rates to below about 7 gpad (70 lphd), since activity on the liner, particularly an uncovered liner, can cause more damage than is resolved.
